## PROPERTY EVIDENCE FILE

## Bathroom damp and mould case

**17 Oak Street, Birmingham, B1 1AA**

**PEF-DEMO-2026-00142-A**

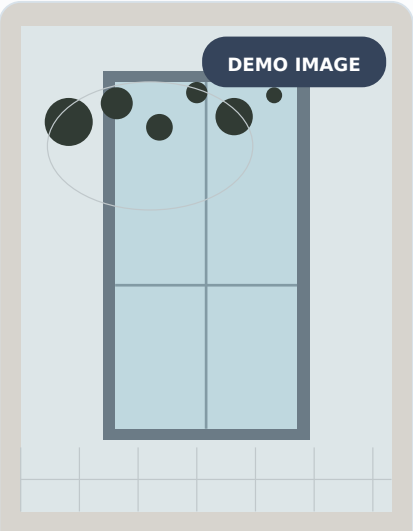
**BEFORE / EV-002**  
03 Sep 2026, 10:17 BST

Existing 100 mm extractor fan operating but airflow materially reduced; unit noisy.

Condensation staining and localised surface mould around the window reveal.

Localised dark surface growth around the upper-left window reveal; condensation visible on glazing.

- Replace bathroom extractor fan with like-for-like humidistat unit.
- Clean and treat affected window reveal with fungicidal wash.
- Remove and renew failed silicone at bath edge.
- Advise tenant to continue ventilation and report recurrence.

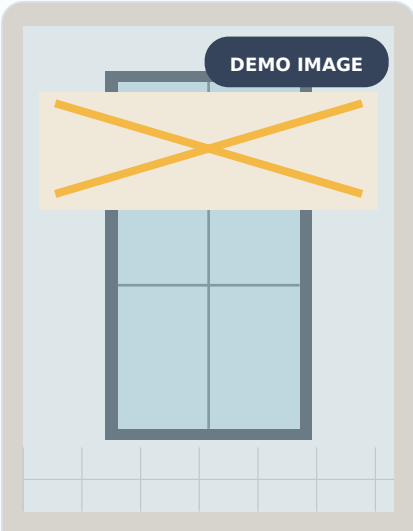
**DURING / JOB LOG**  
07 Sep 2026, 11:46 BST

Bath-edge silicone failed in two sections and showed surface mould.

Affected surface isolated during treatment; old silicone removed before renewal.

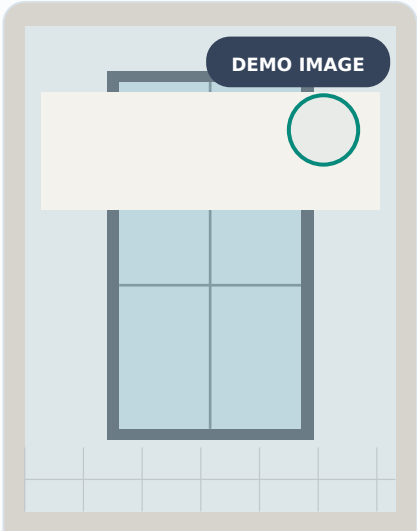
**AFTER / EV-005**  
07 Sep 2026, 14:15 BST

Treated reveal repainted, silicone renewed and replacement fan installed.

Extractor fan replaced, affected surfaces treated and bath-edge silicone renewed. Completion was recorded by the contractor and supported by a photograph and invoice.
